**Subject: Annual Inspection Report
Greensboro Municipal Airport**

ANNUAL INSPECTION REPORT

DECEMBER 21, 2010

GREENSBORO MUNICIPAL AIRPORT
GREENSBORO, ALABAMA

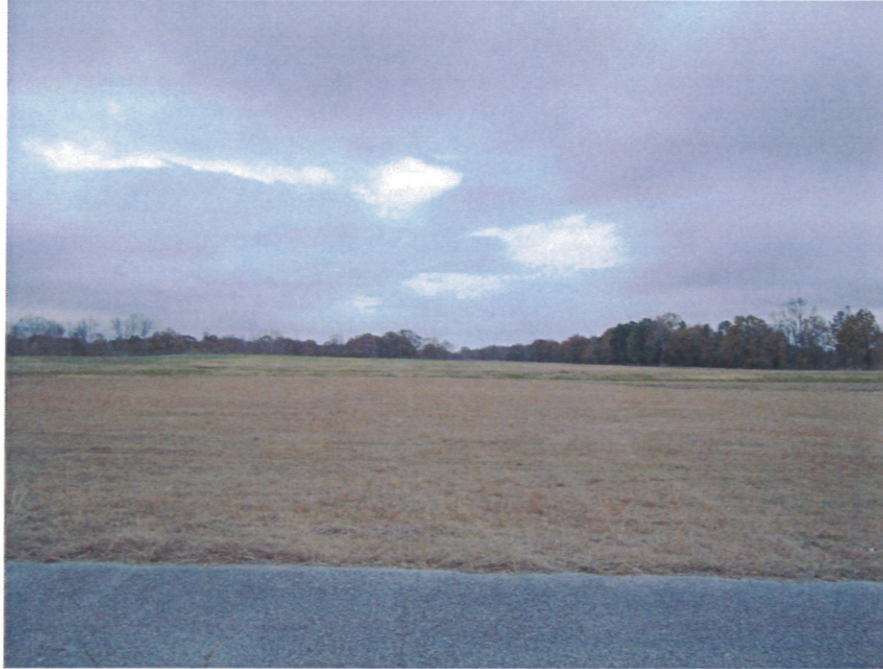
Photo 1

- The Approach/Departure Paths of each runway end meet licensing requirements.

Approach to Runway 18

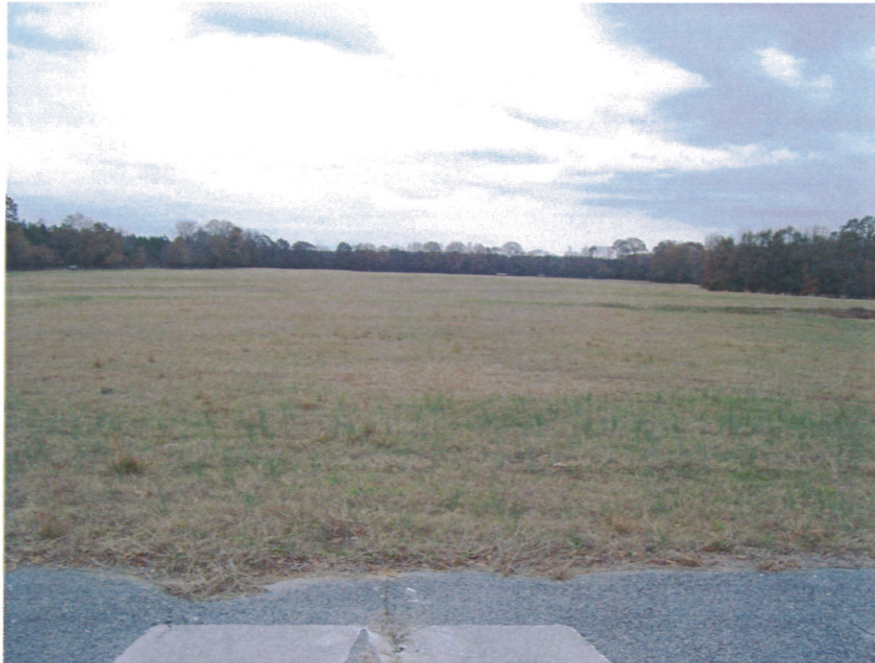
Photo 2

Approach to Runway 36

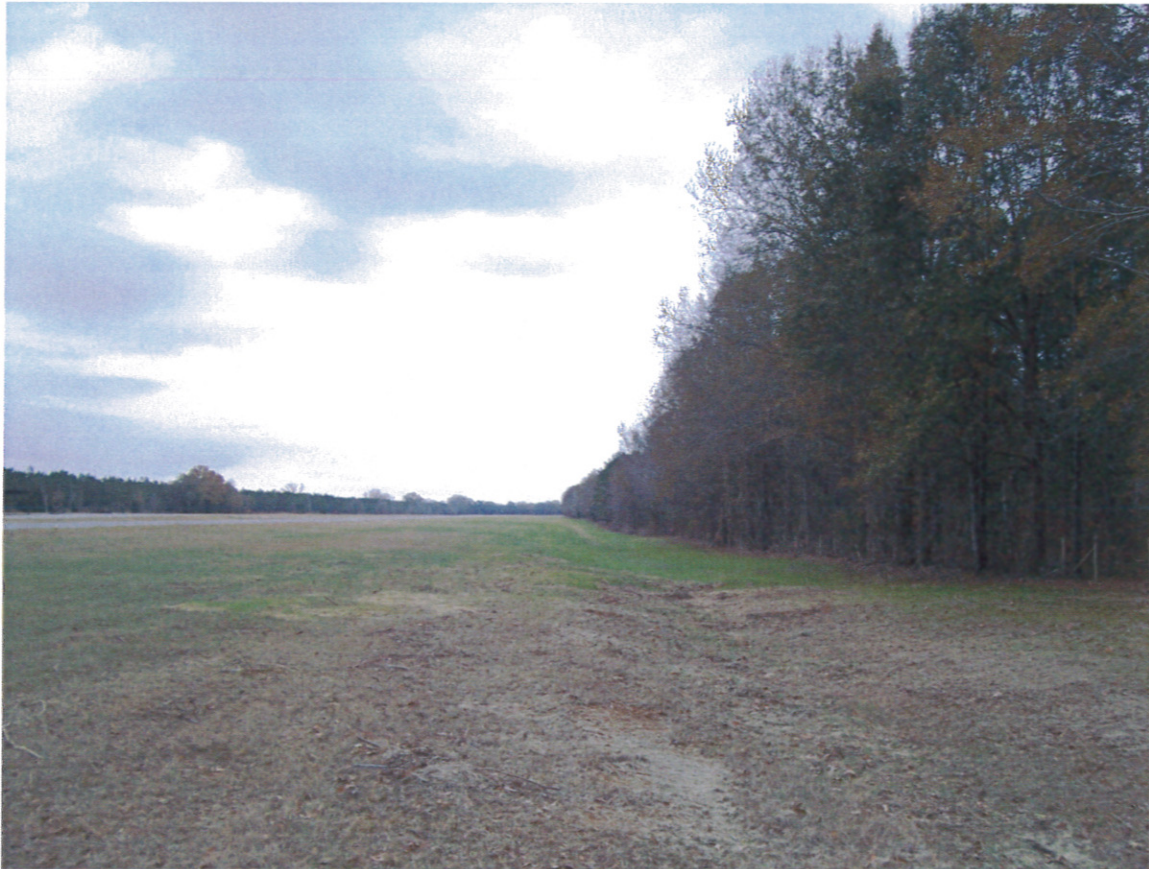
Photo 3

- ➔ The Primary Surface was found to meet state safety requirements.

West side of runway property recently cleared

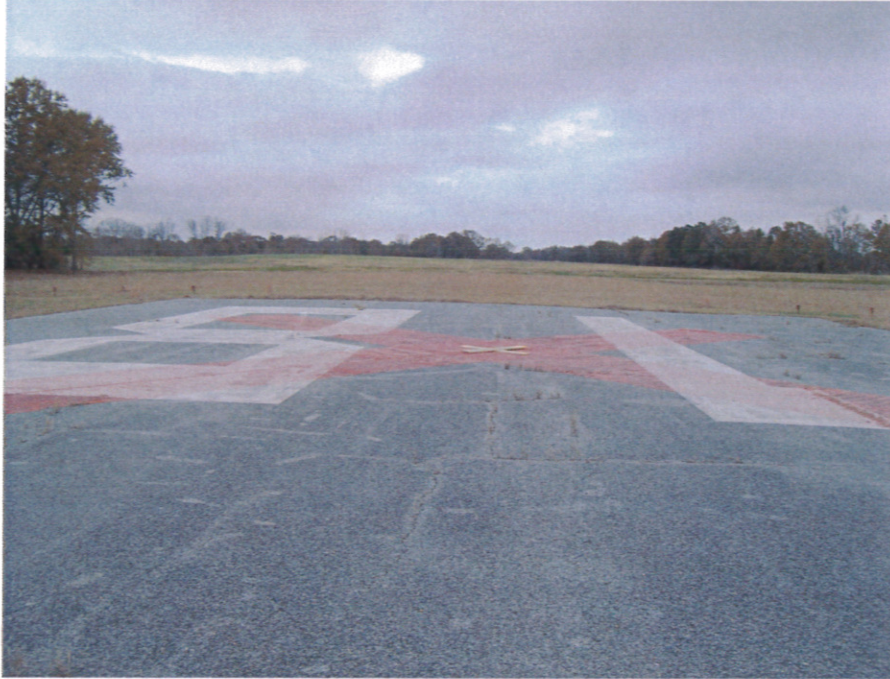
Photo 4

- ➔ The airport markings are in Good condition.

Runway 18 basic markings

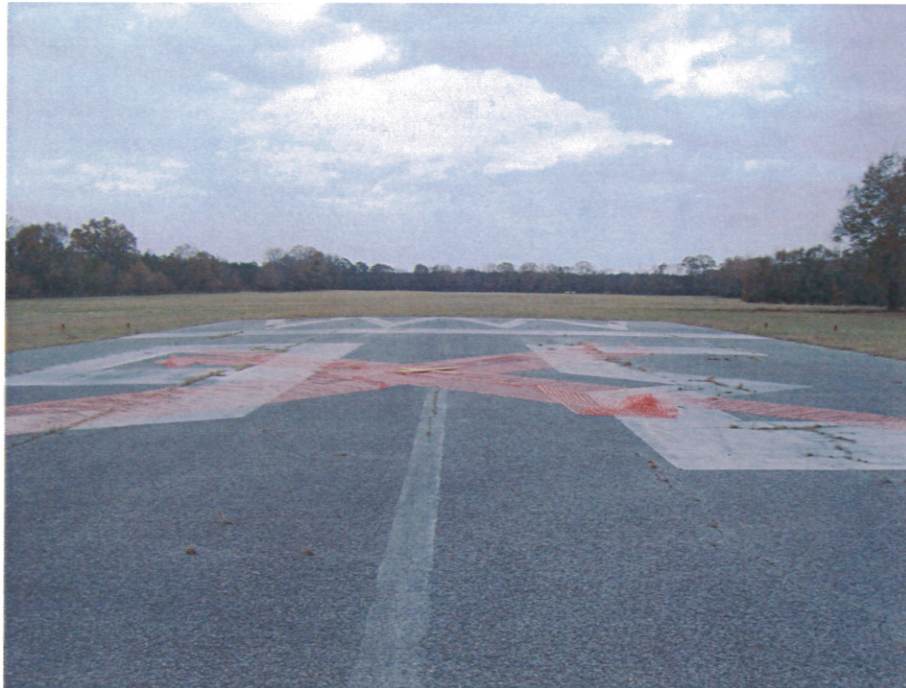
Photo 5

Runway 36 basic markings

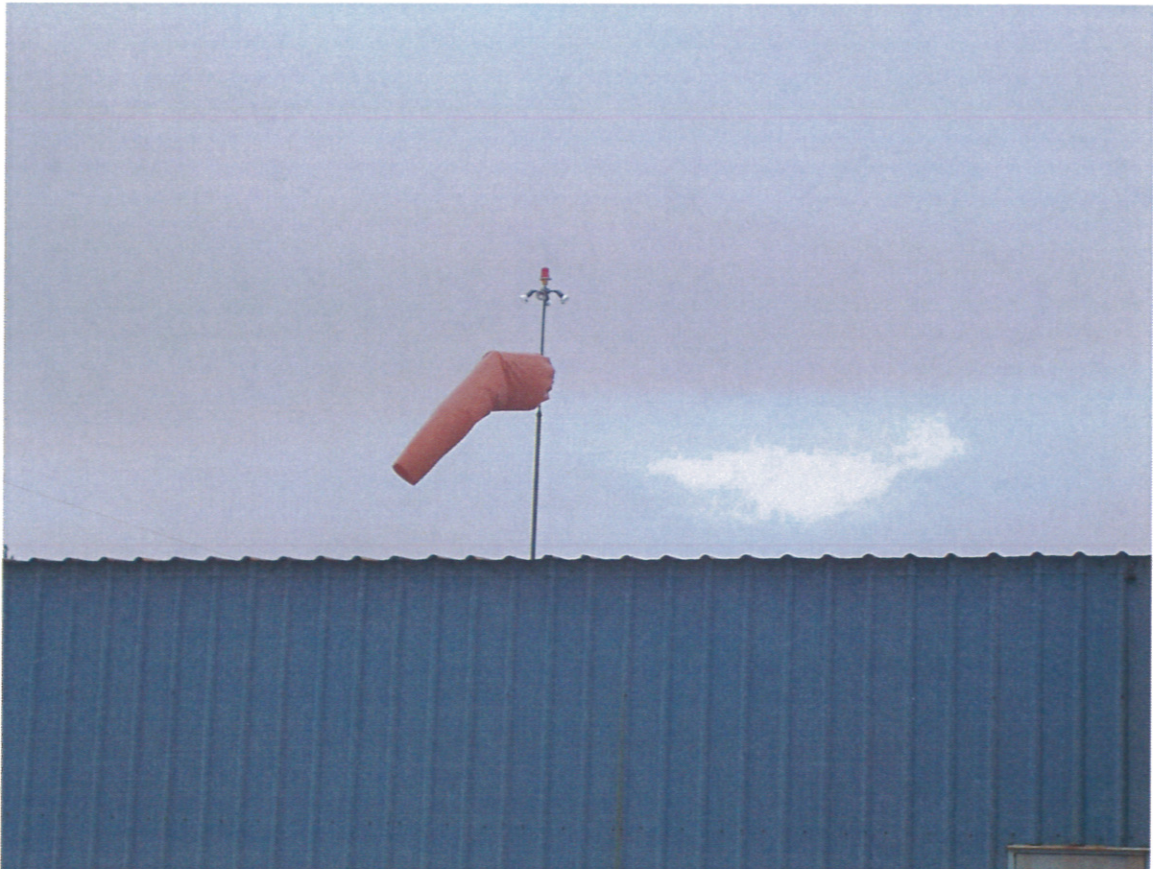
Photo 6

- The wind direction indicator meets licensing requirements.

Windsock assembly

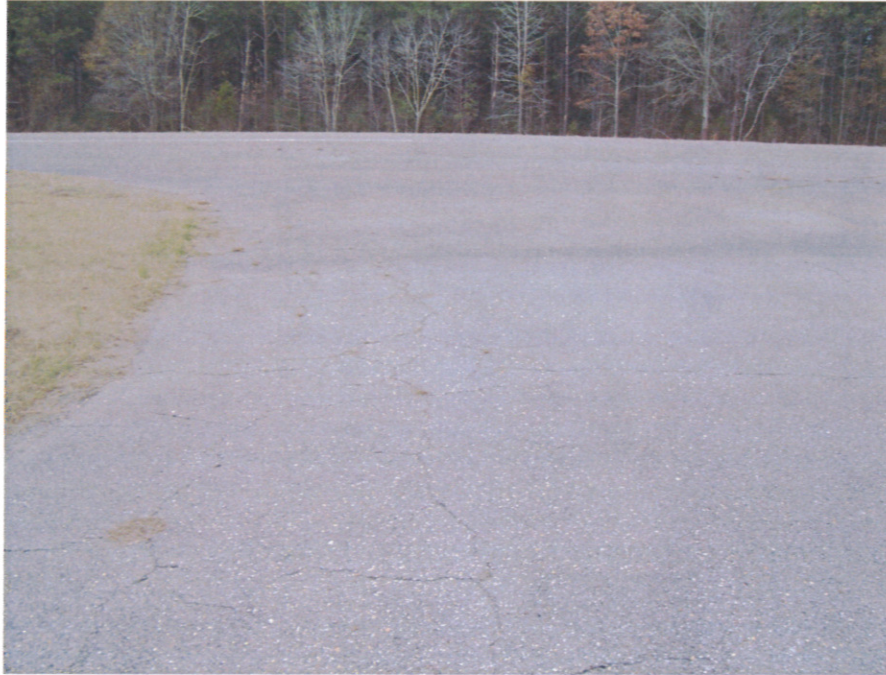
Photo 7

- ➔ The asphalt surfaces are in Fair to Poor condition.
- ➔ The runway has areas of reflective cracking with vegetation.
- ➔ The runway has areas of raveling with loose aggregate.
- ➔ The southernmost taxiway is block cracked with vegetation.
- ➔ The apron has areas of alligator cracking and block cracking.
- ➔ The drain pipes under the two taxiways needs to be replaced. The south taxiway pipe is collapsed on the outlet.
- ➔ The drainage ditch south of the apron has been graded and grassed with erosion control in place.

North taxiway pavement cracking

- ➔ The runway, apron, and taxiways must be overlayed in the near future.
- ➔ The drainage structures beneath the taxiways must be replaced.

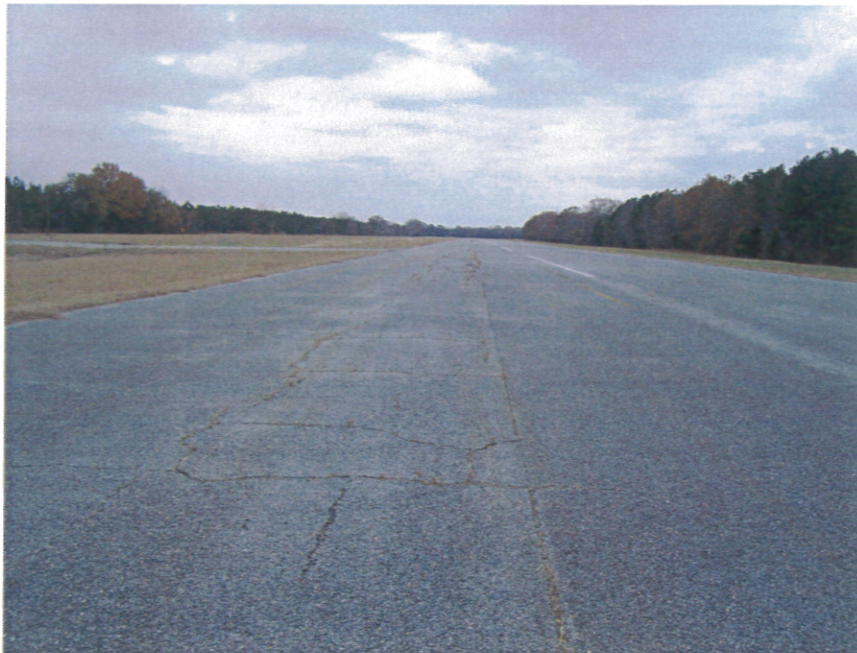
Photo 8

Reflective cracking on runway

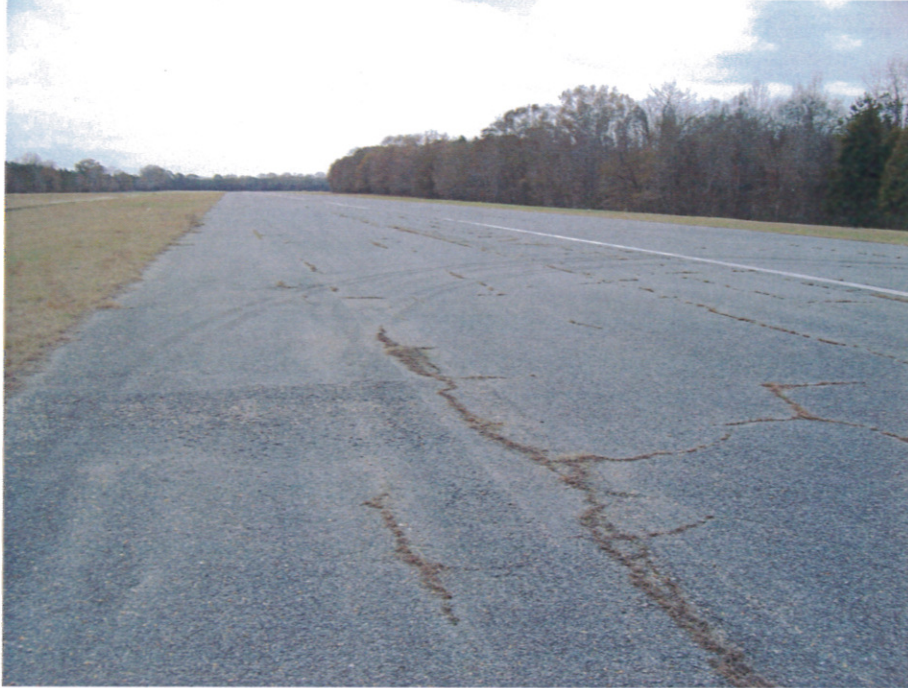
Photo 9

Runway cracking with vegetation

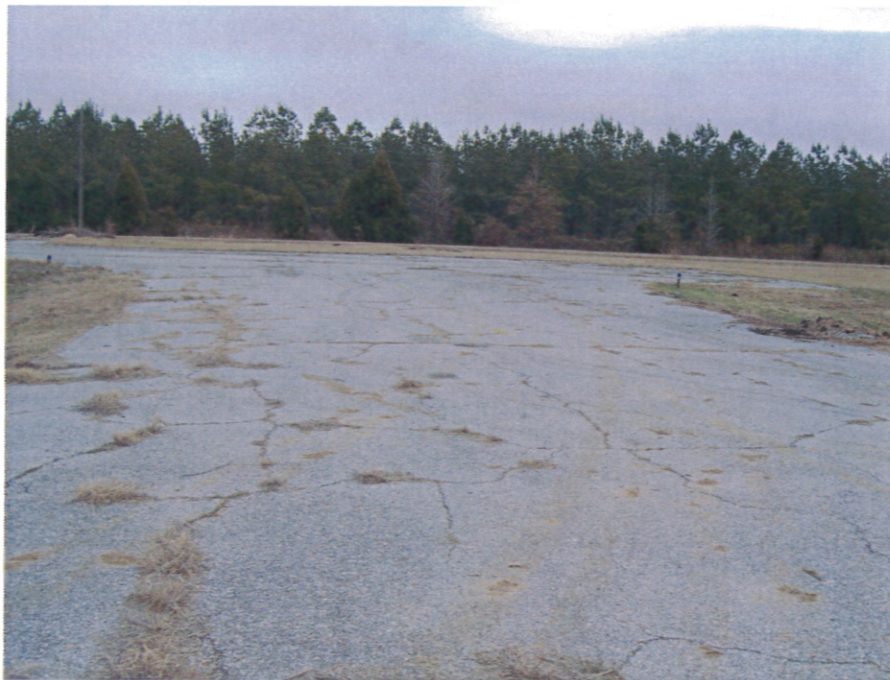
Photo 10

South taxiway cracking with vegetation

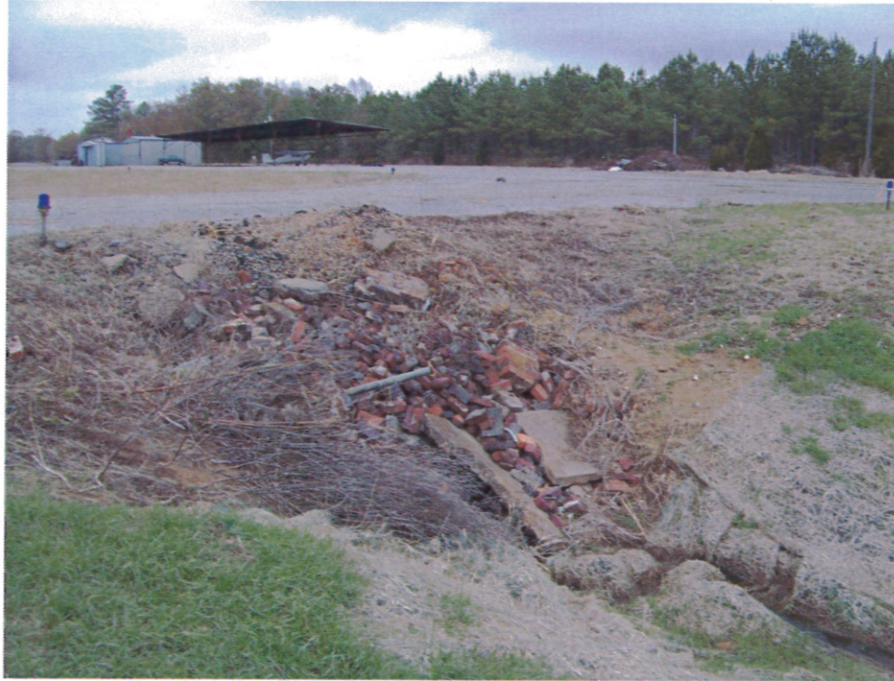
Photo 11

Outlet end of the drainage pipe on south taxiway

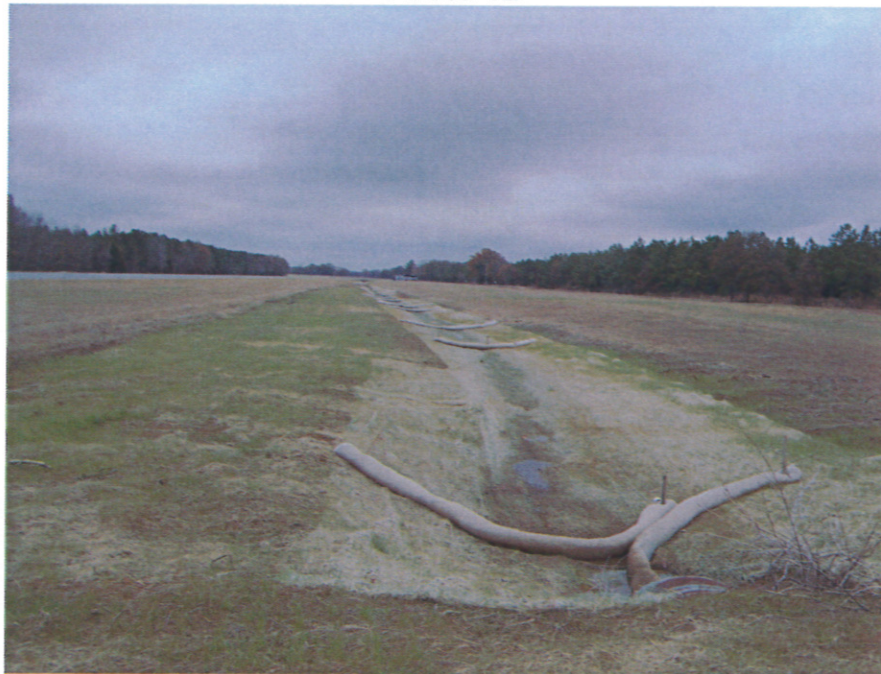
Photo 12

Recently completed drainage improvements

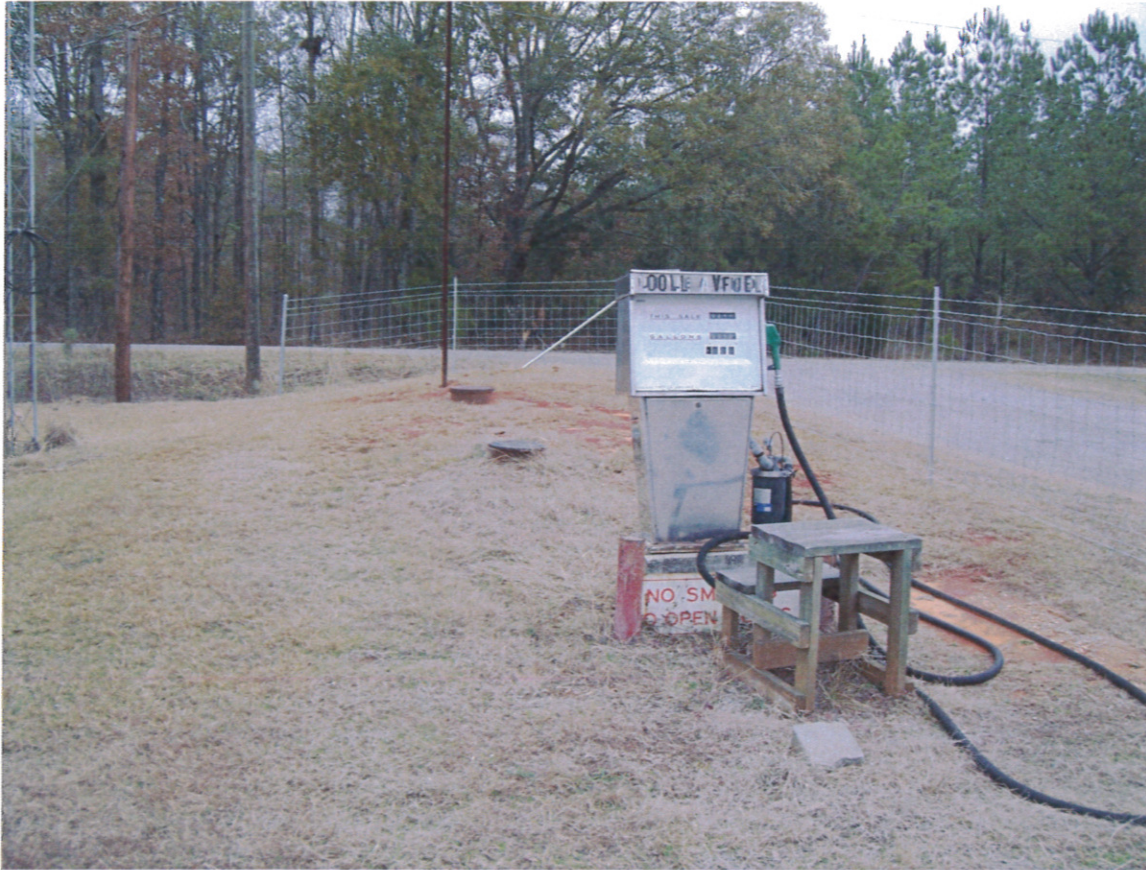
Photo 12

- ➔ The fuel is dispensed from a pump.
- ➔ The fuel is stored in an underground tank.
- ➔ There is no fire extinguisher located at the fueling area.

Fuel pump with underground storage tank behind

- ➔ Place an extinguisher at the fueling area.
